## Plug Strainer Upgrade Due to Magnetite Problems

Carter Process Control GmbH has been working with clients globally that experience plug sticking problems due to magnetite build up in turbine bypass valves and provide the following solution to this problem.

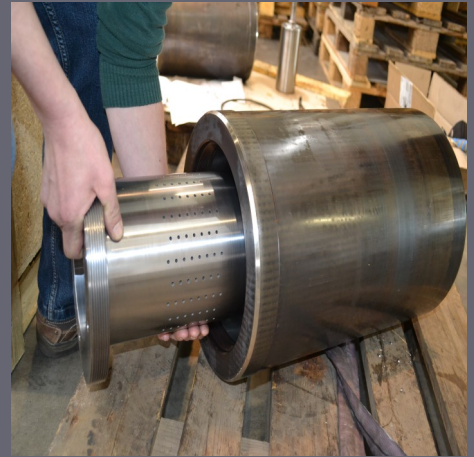
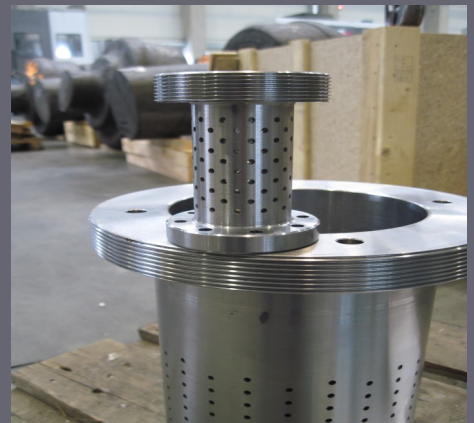
- **Magnetite**—This is where there is a build up of iron oxide or magnetite commonly seen in hot reheat and high pressure turbine bypass valves.
- **Longer Maintenance Intervals**—The plug strainer upgrade provided by CPC allows for longer periods between maintenance as the strainer collects the magnetite and can be opened and emptied at a scheduled maintenance stop.

- **Stiction**—With the magnetite build up on the top of the plug stiction/blocking occurs but with the upgraded plug strainer this is avoided so the valve operates at its optimum performance.
